July 30, 2015

Re: Wade (ABM) Site

Wade - Summary of VOCs Remaining over the MSCs

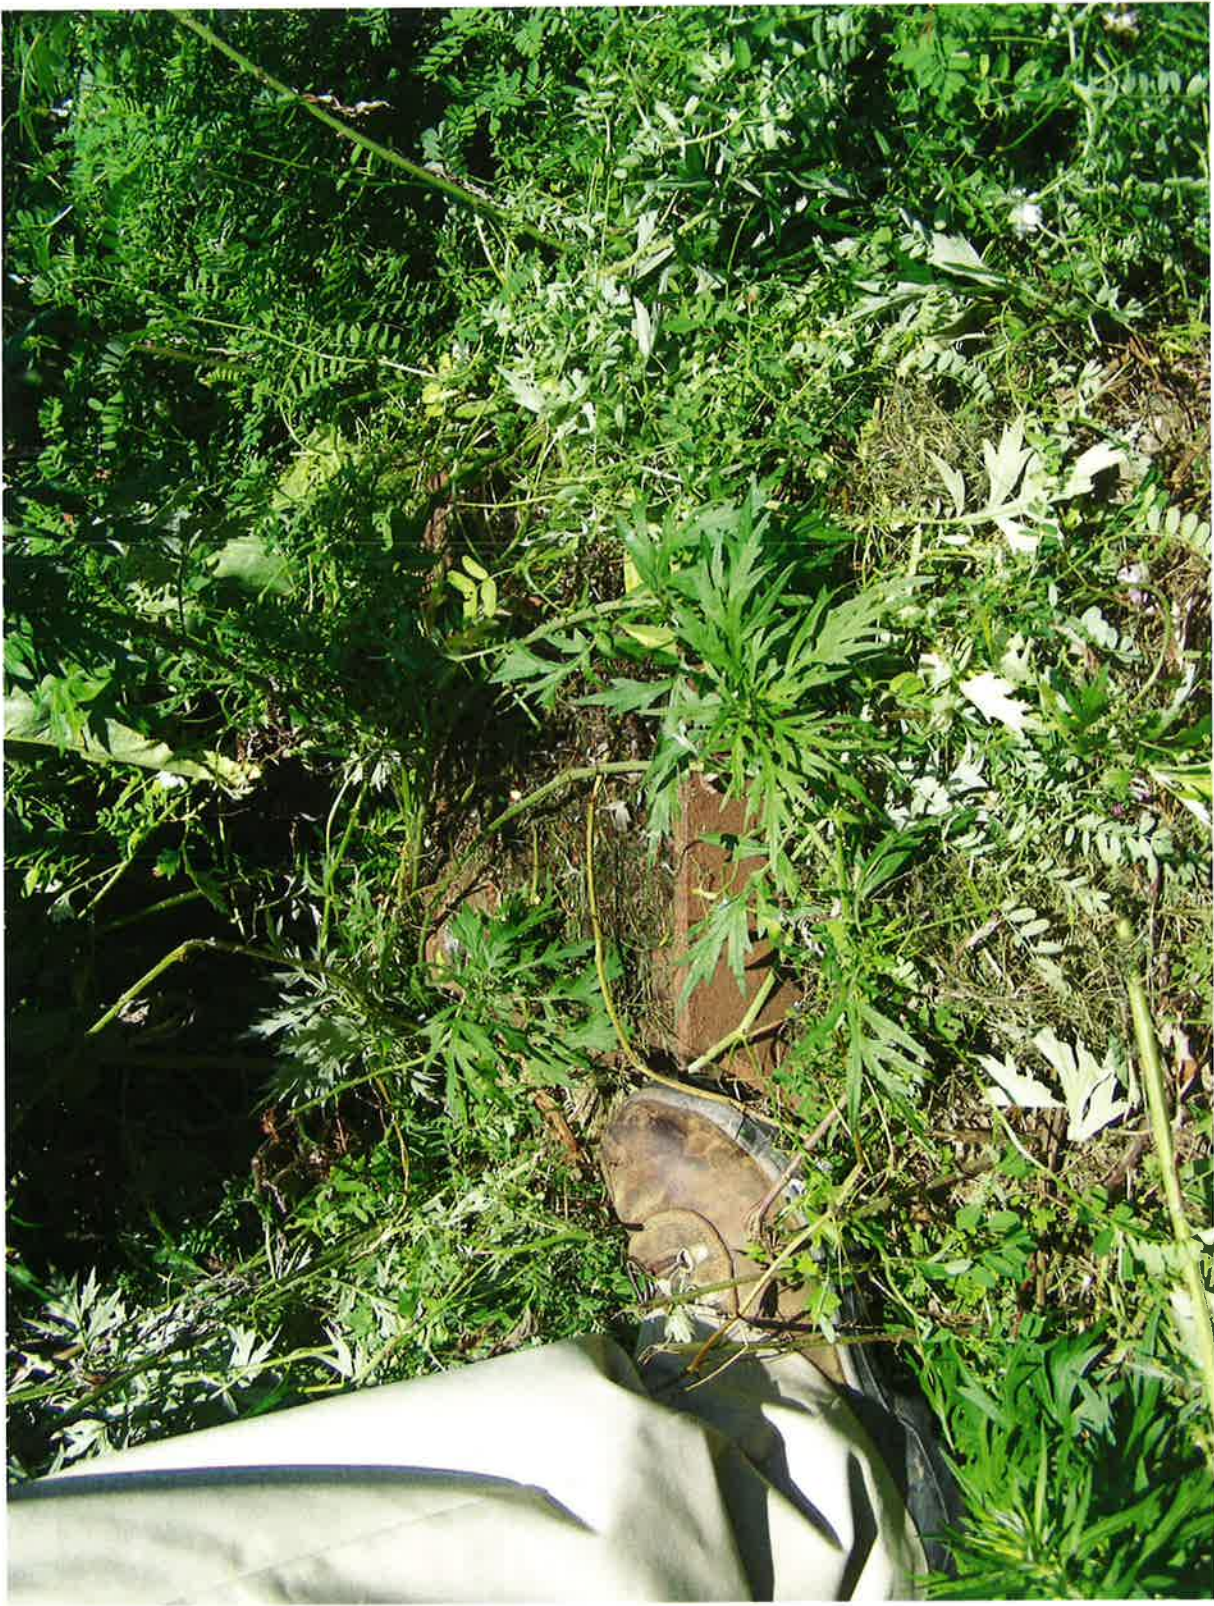
MW-1S:Overgrown vegetation makes access to well difficult

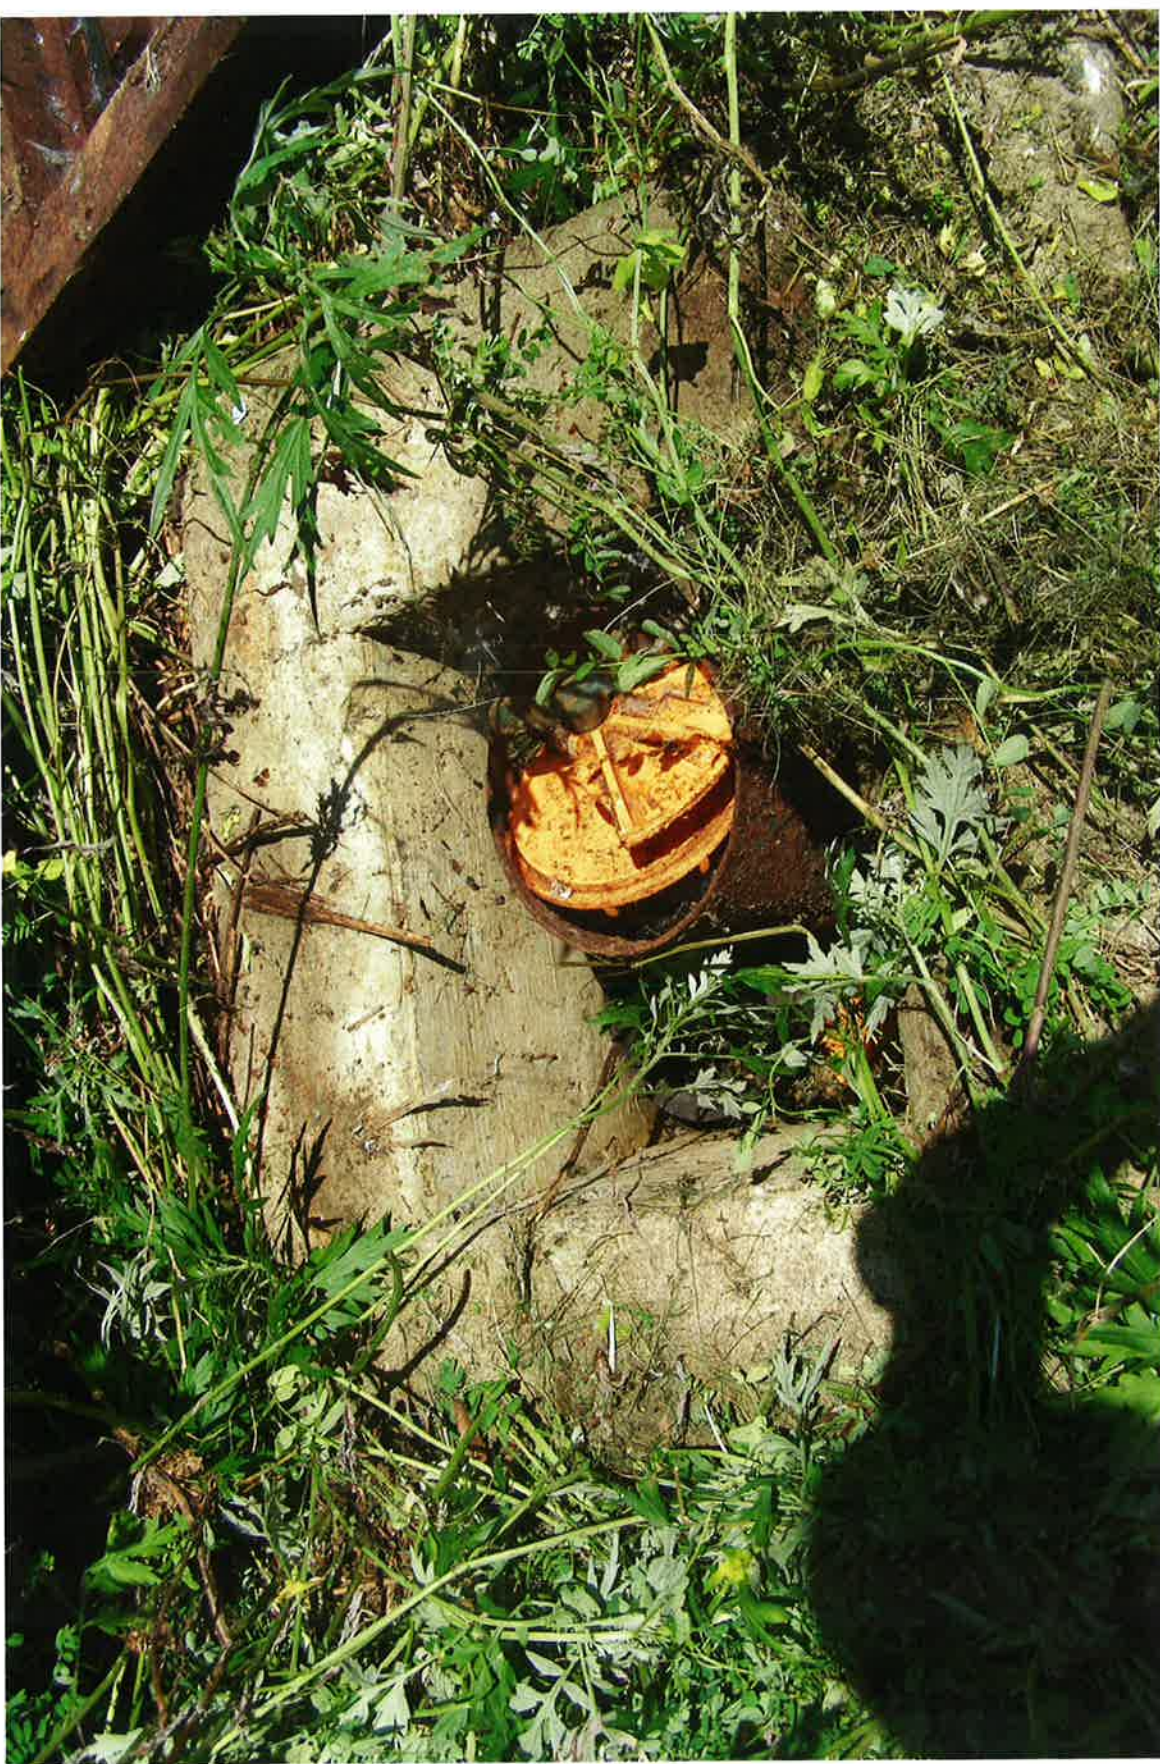
MW-1S: Well cover and cap are not secure

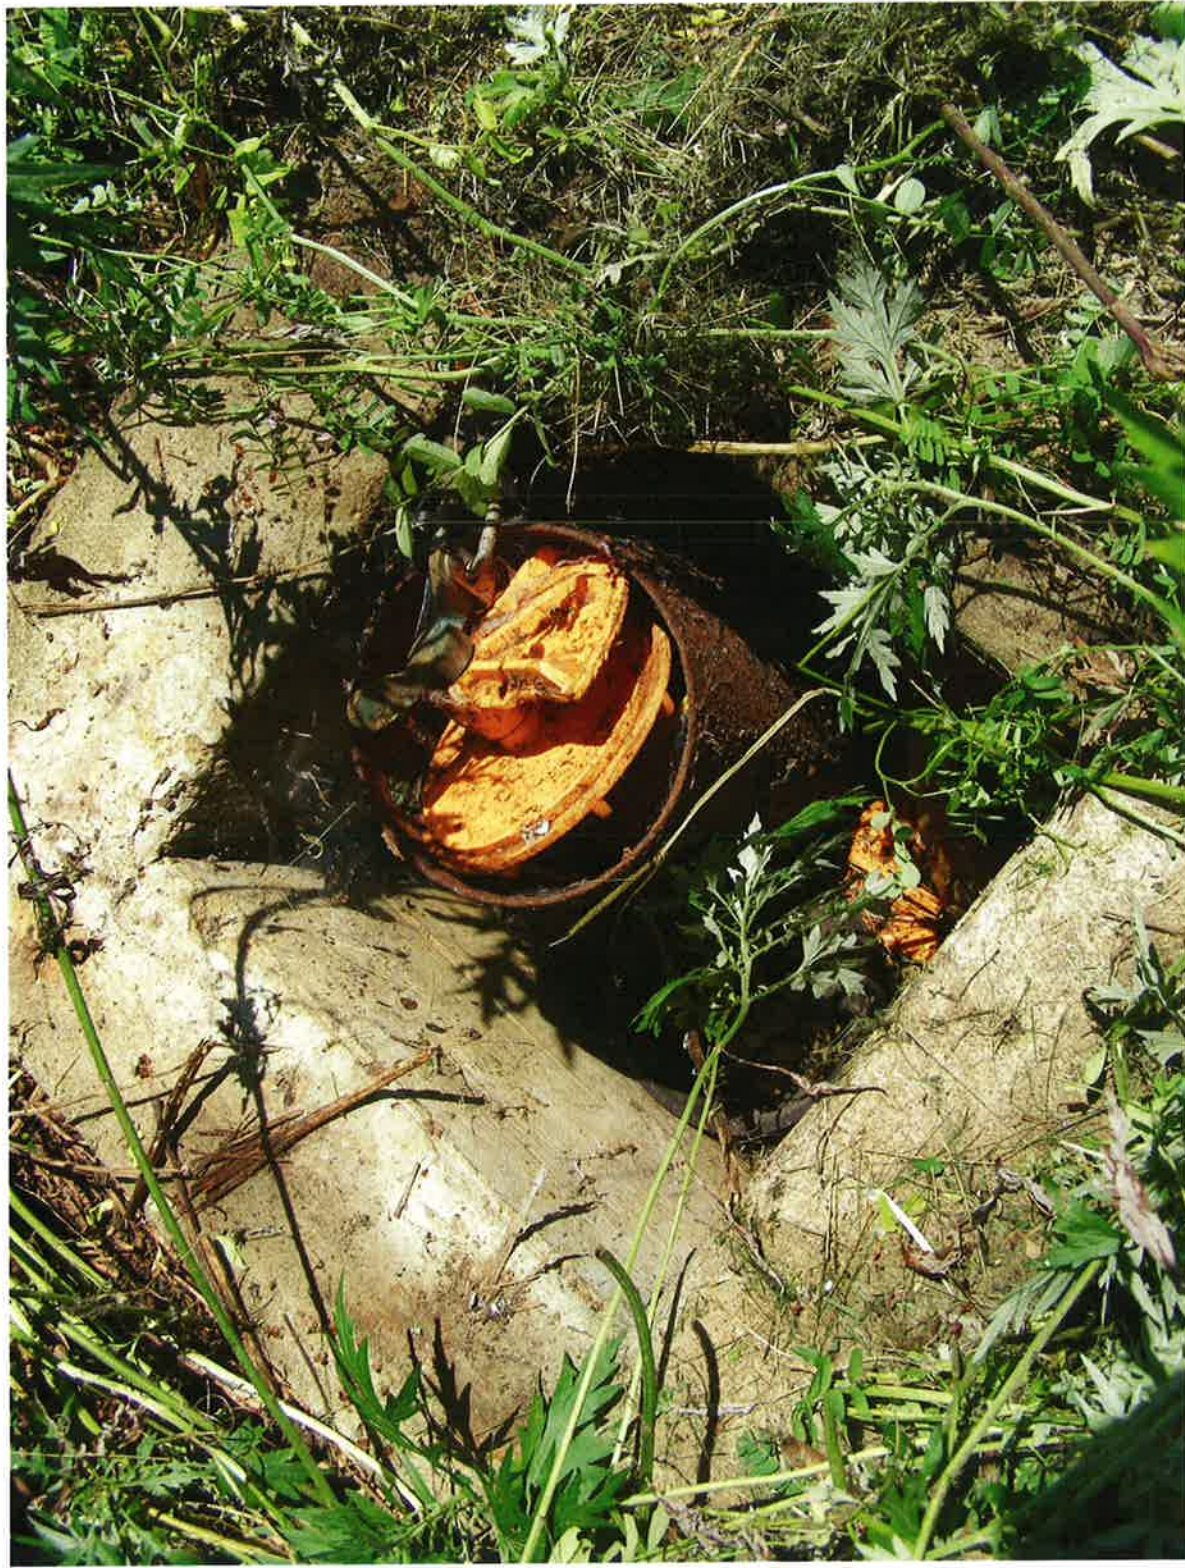
MW-1S: Well cap is not secure

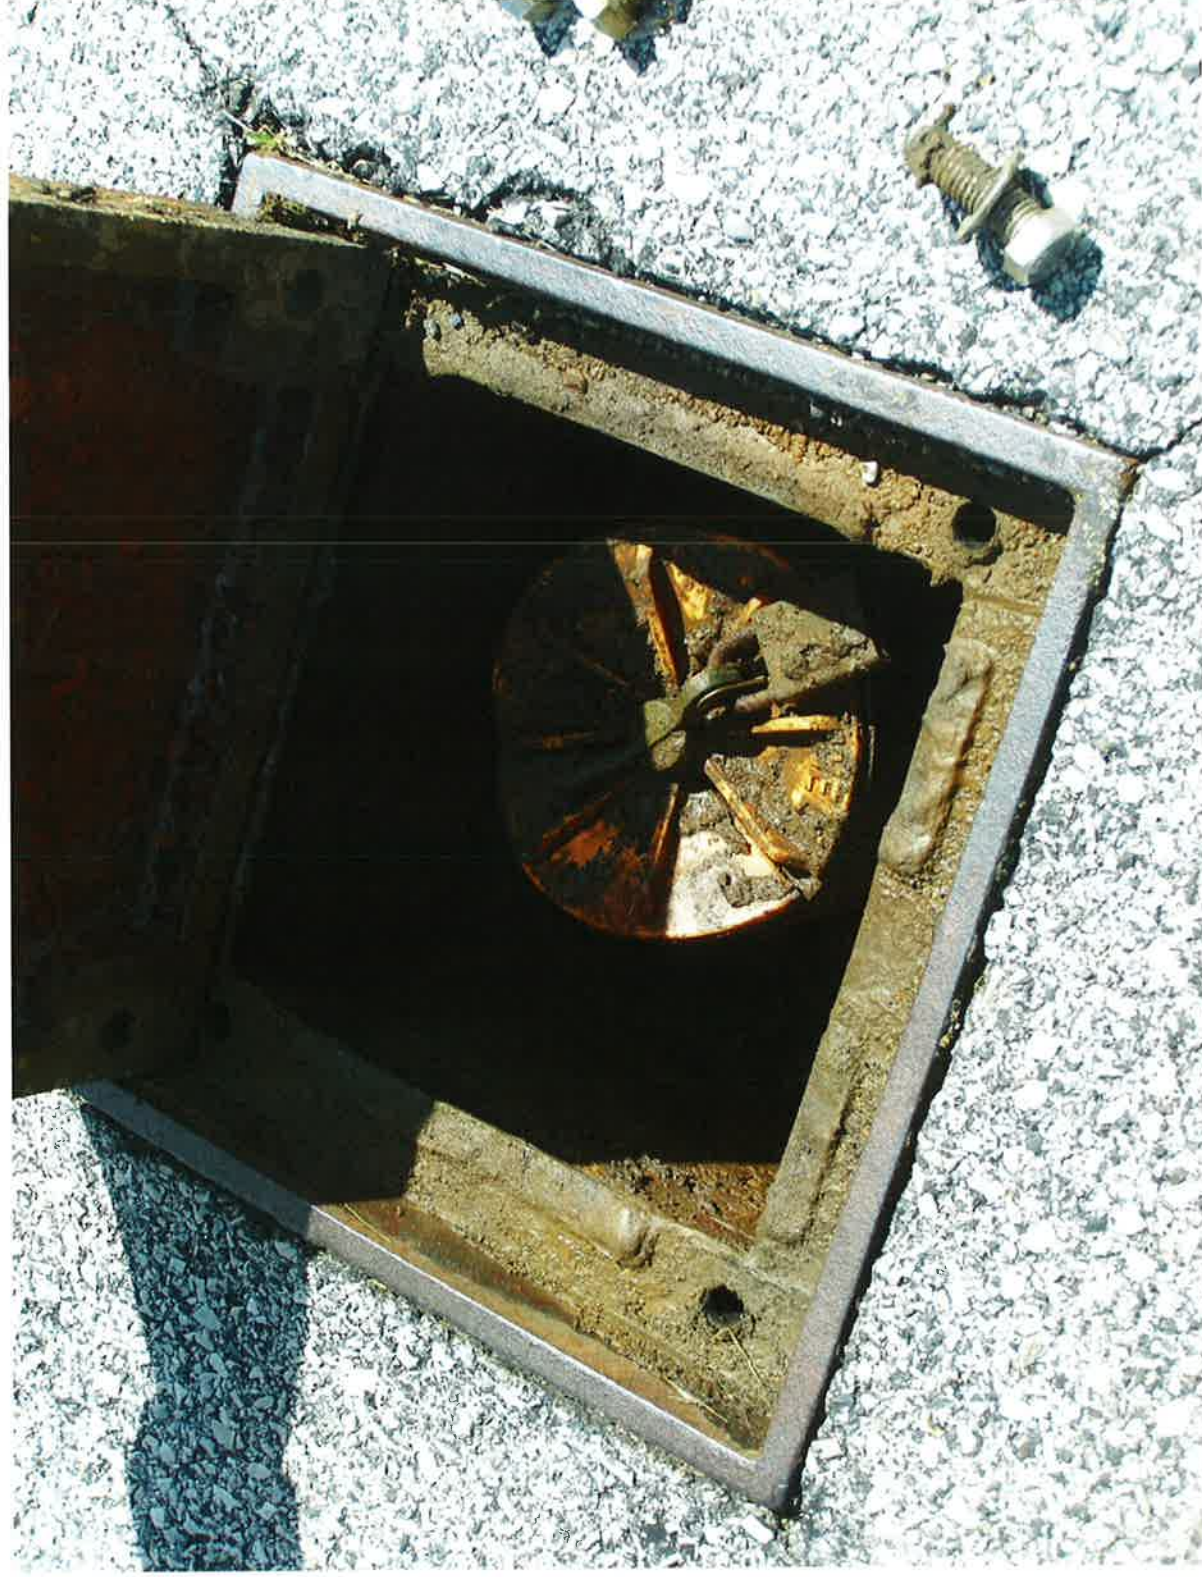
MW-4D: Well cap is not secure

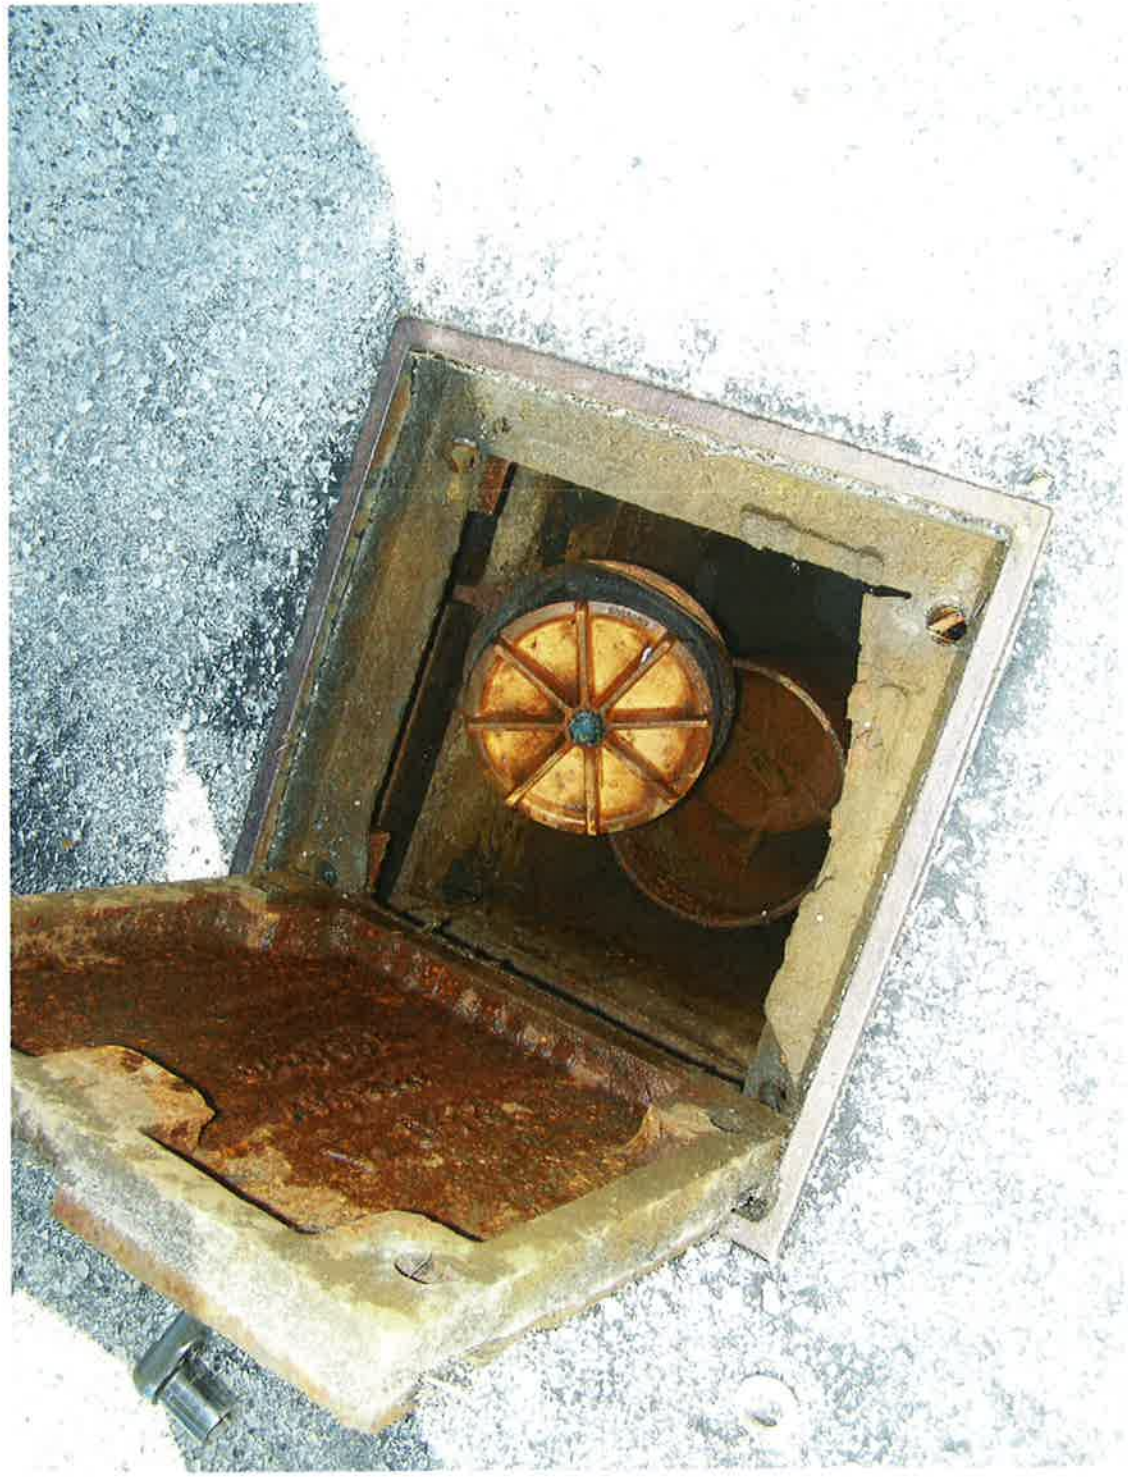
MW-4S: Well cap is not secure and flooding has caused water to infiltrate

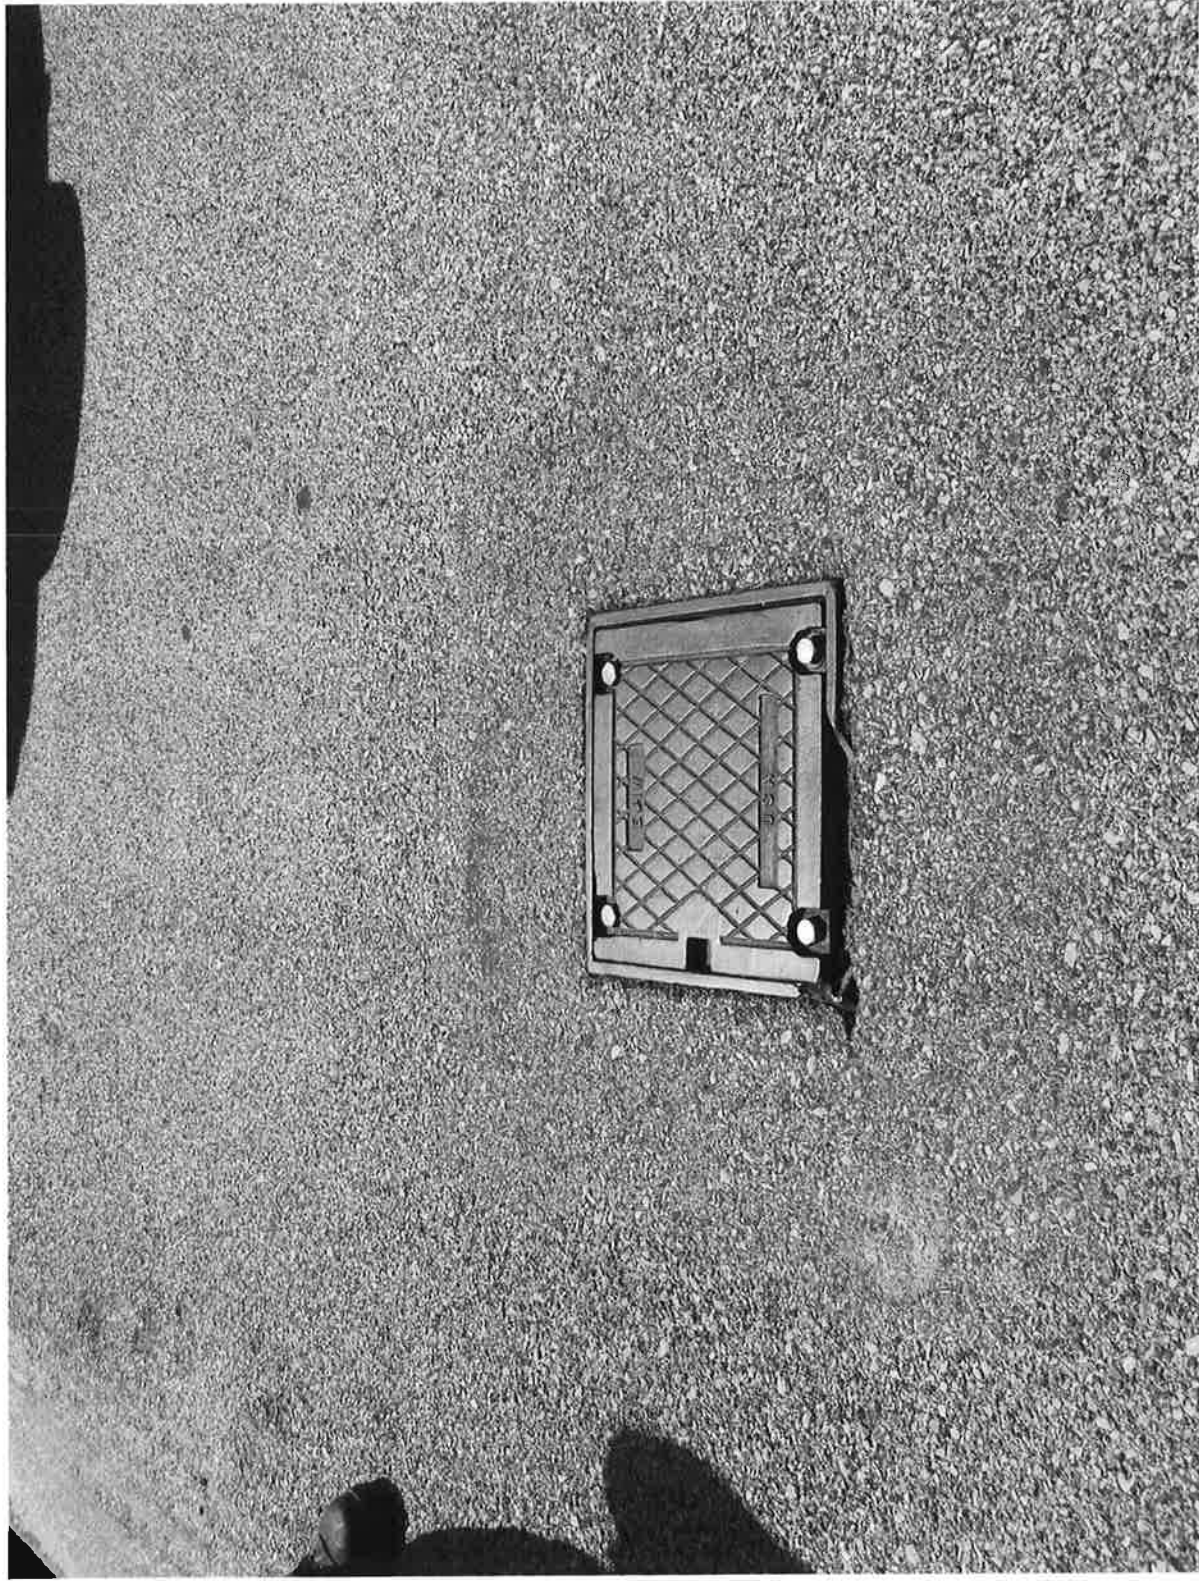
MW-5S: Well is placed in middle of street and experiences heavy vehicle traffic causing damage to well cover

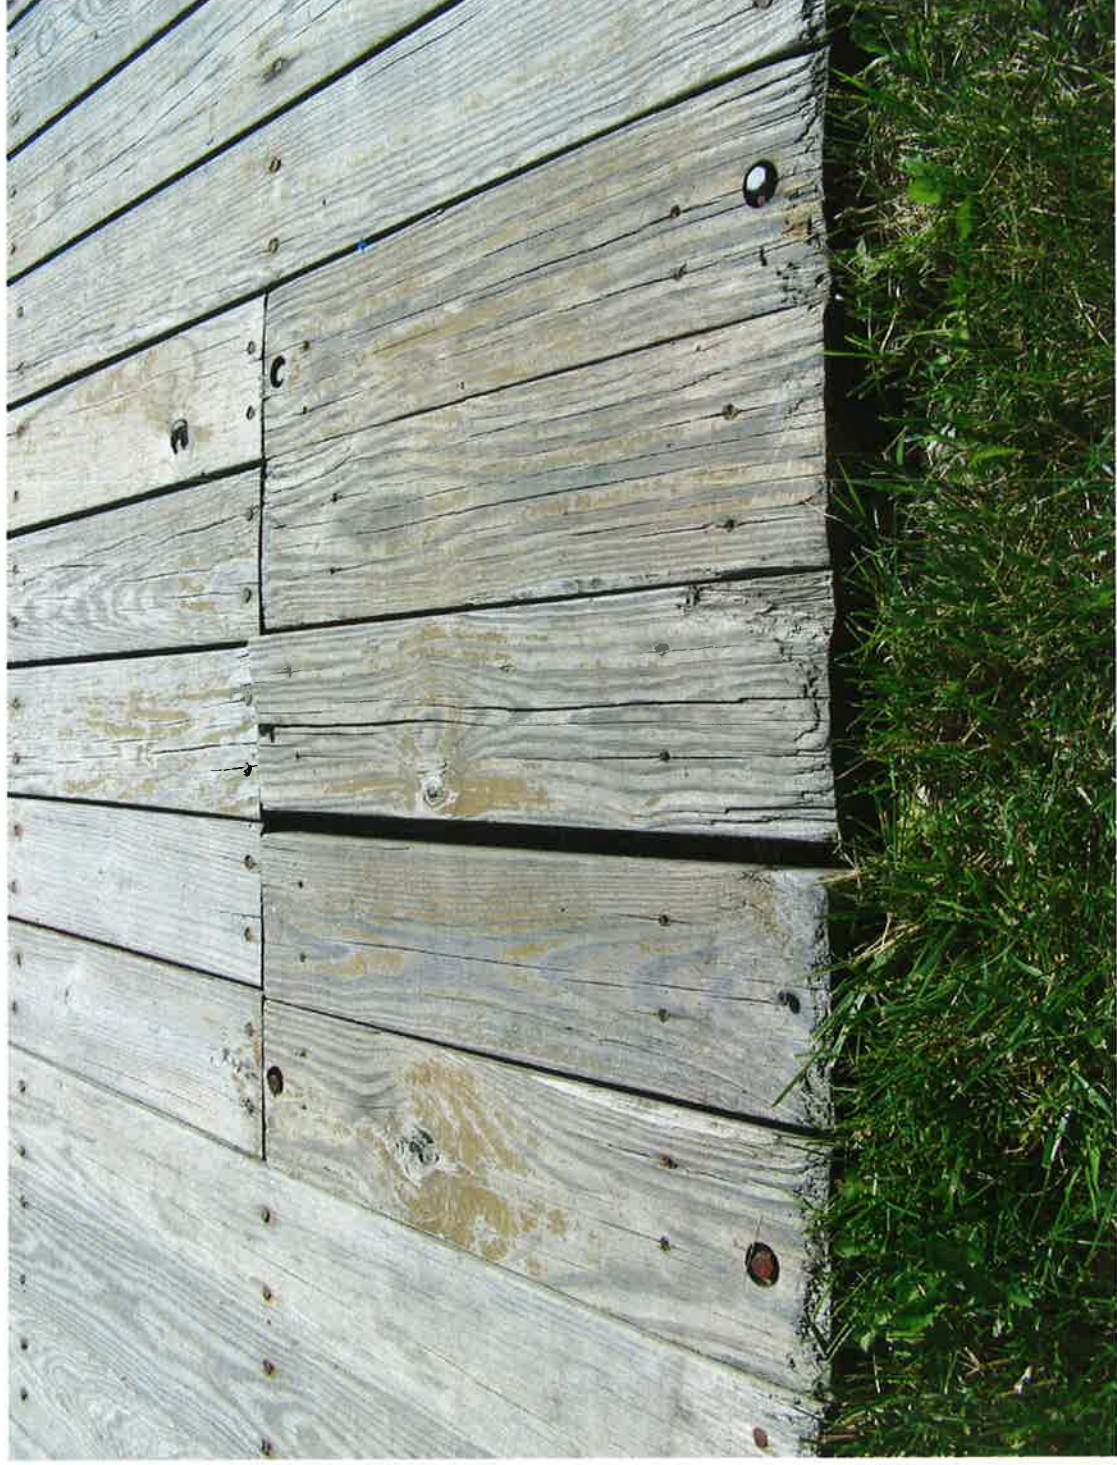
MW-7S: Planks covering well are not secure and pose trip/fall hazard to pedestrians

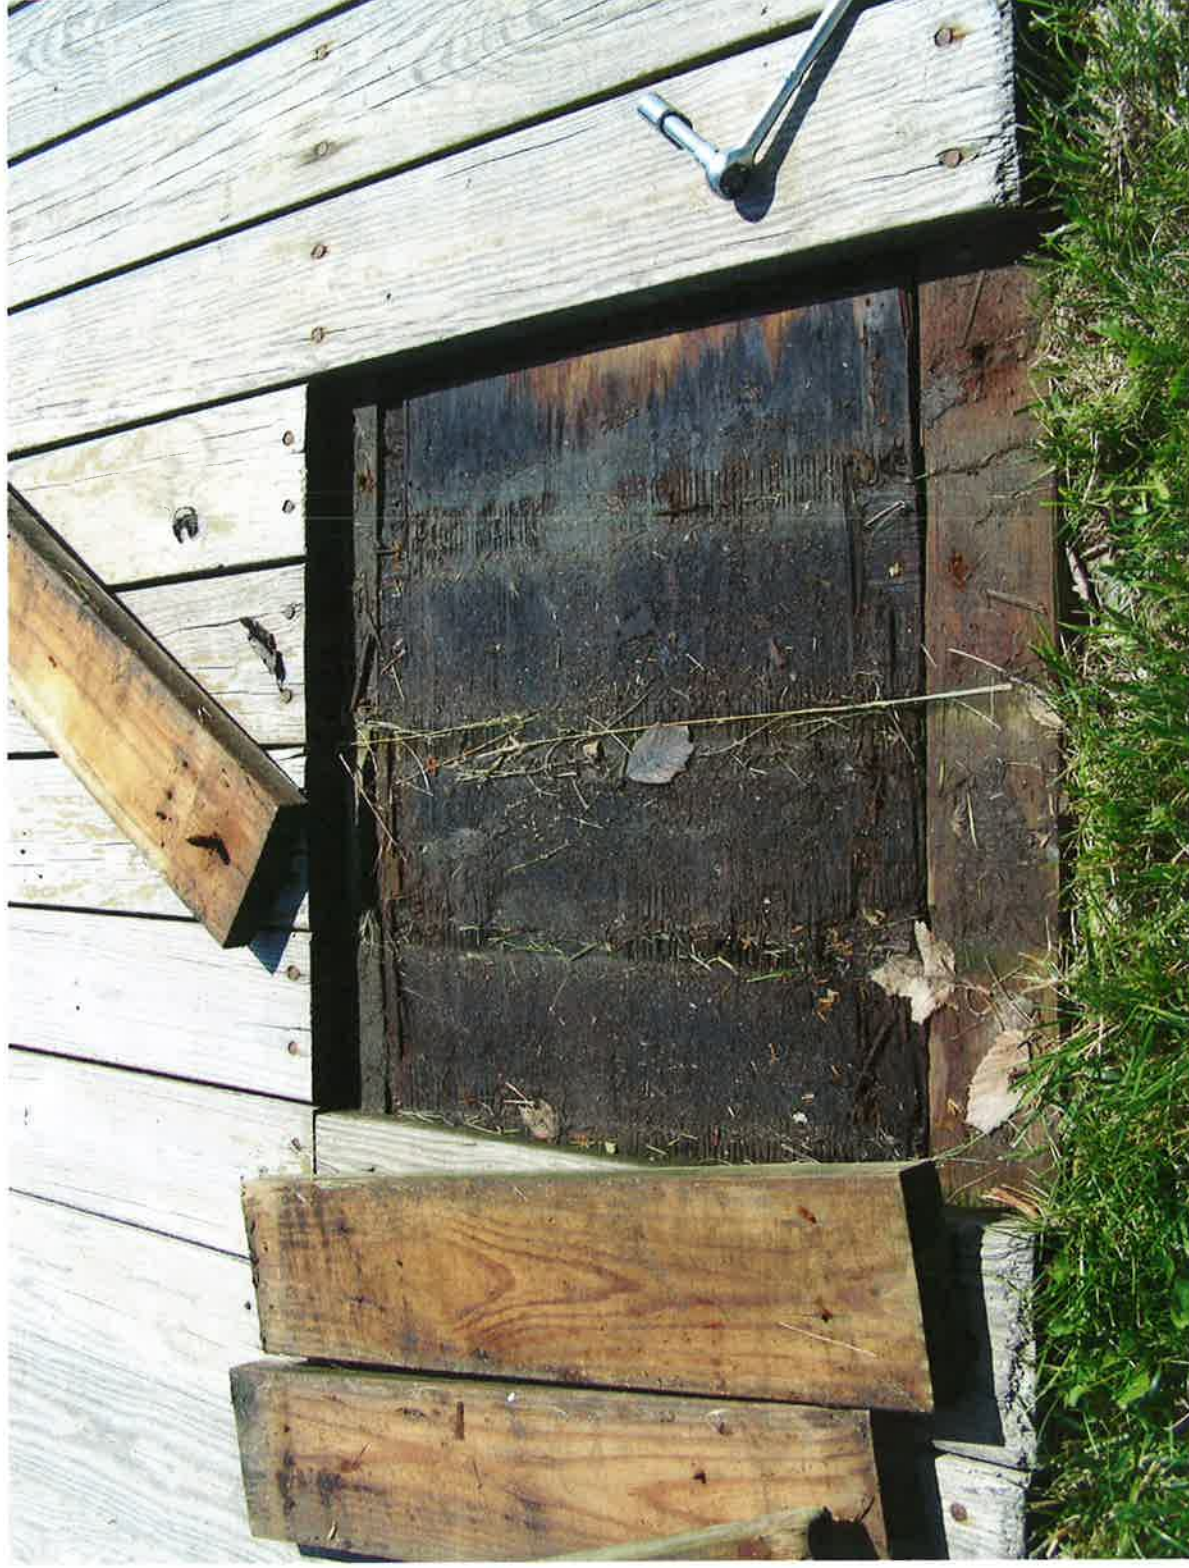
MW-7S: Planks are not secure and plywood covering well cap is rotting

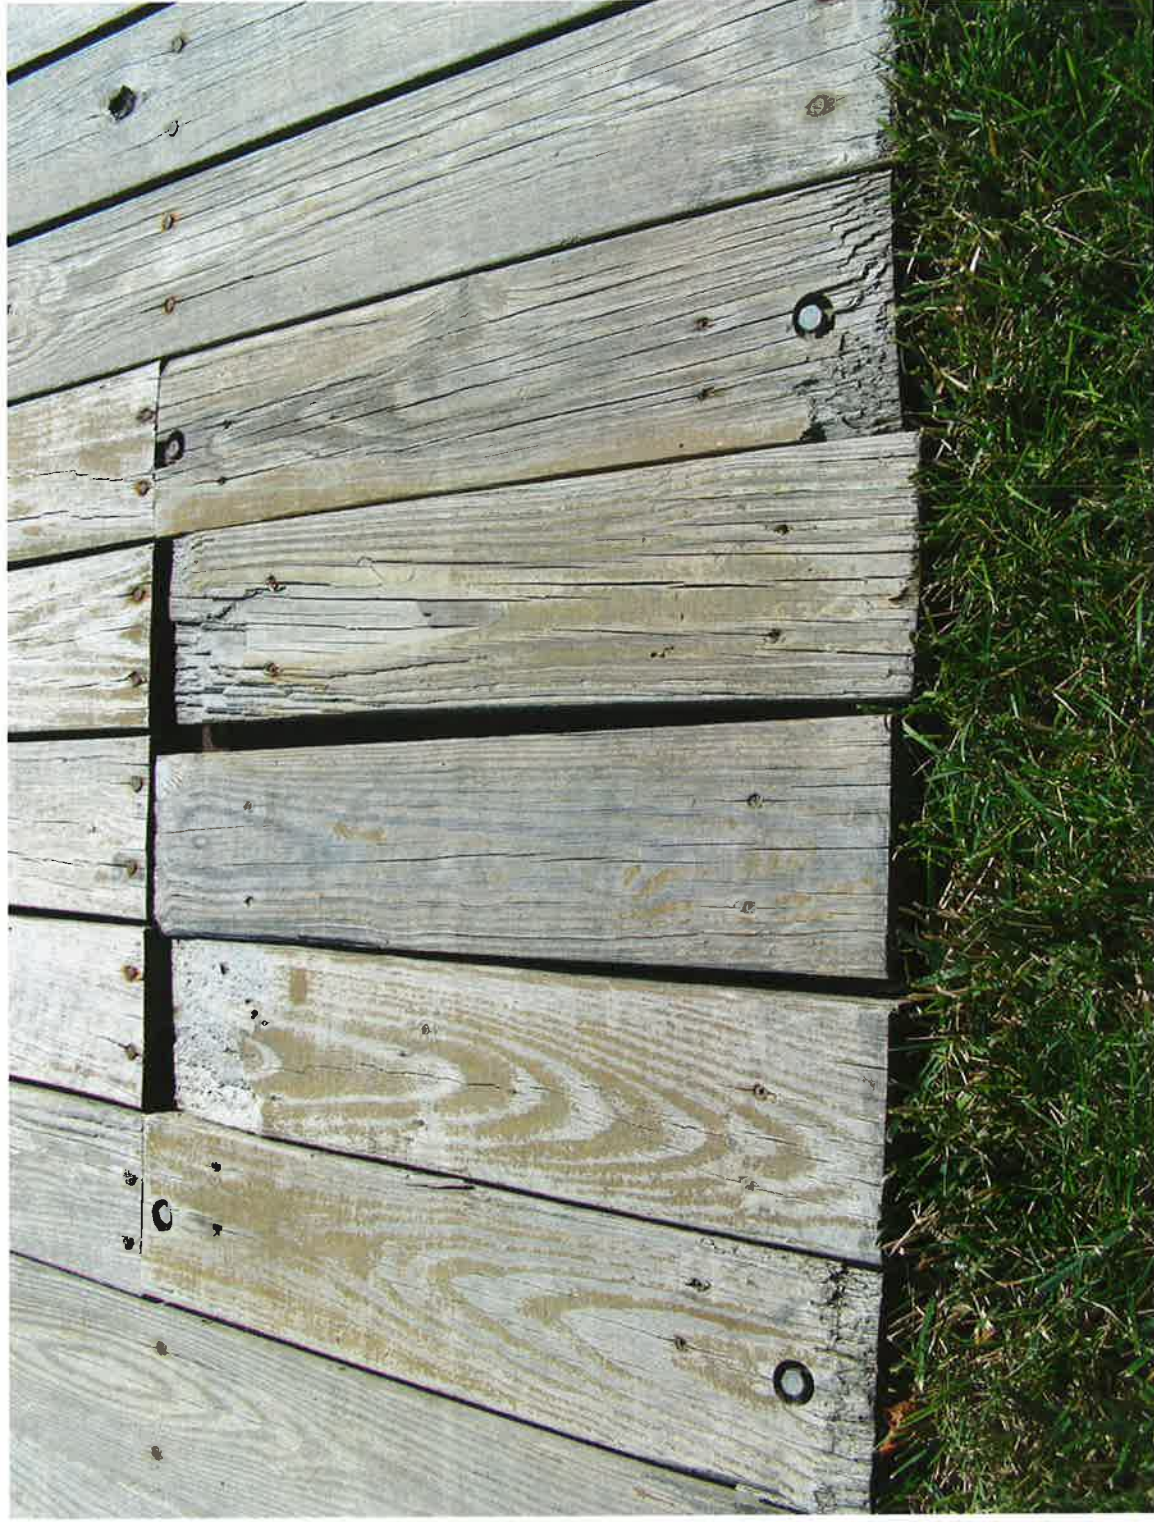
MW-7D: Planks are not secure and pose trip/fall hazard

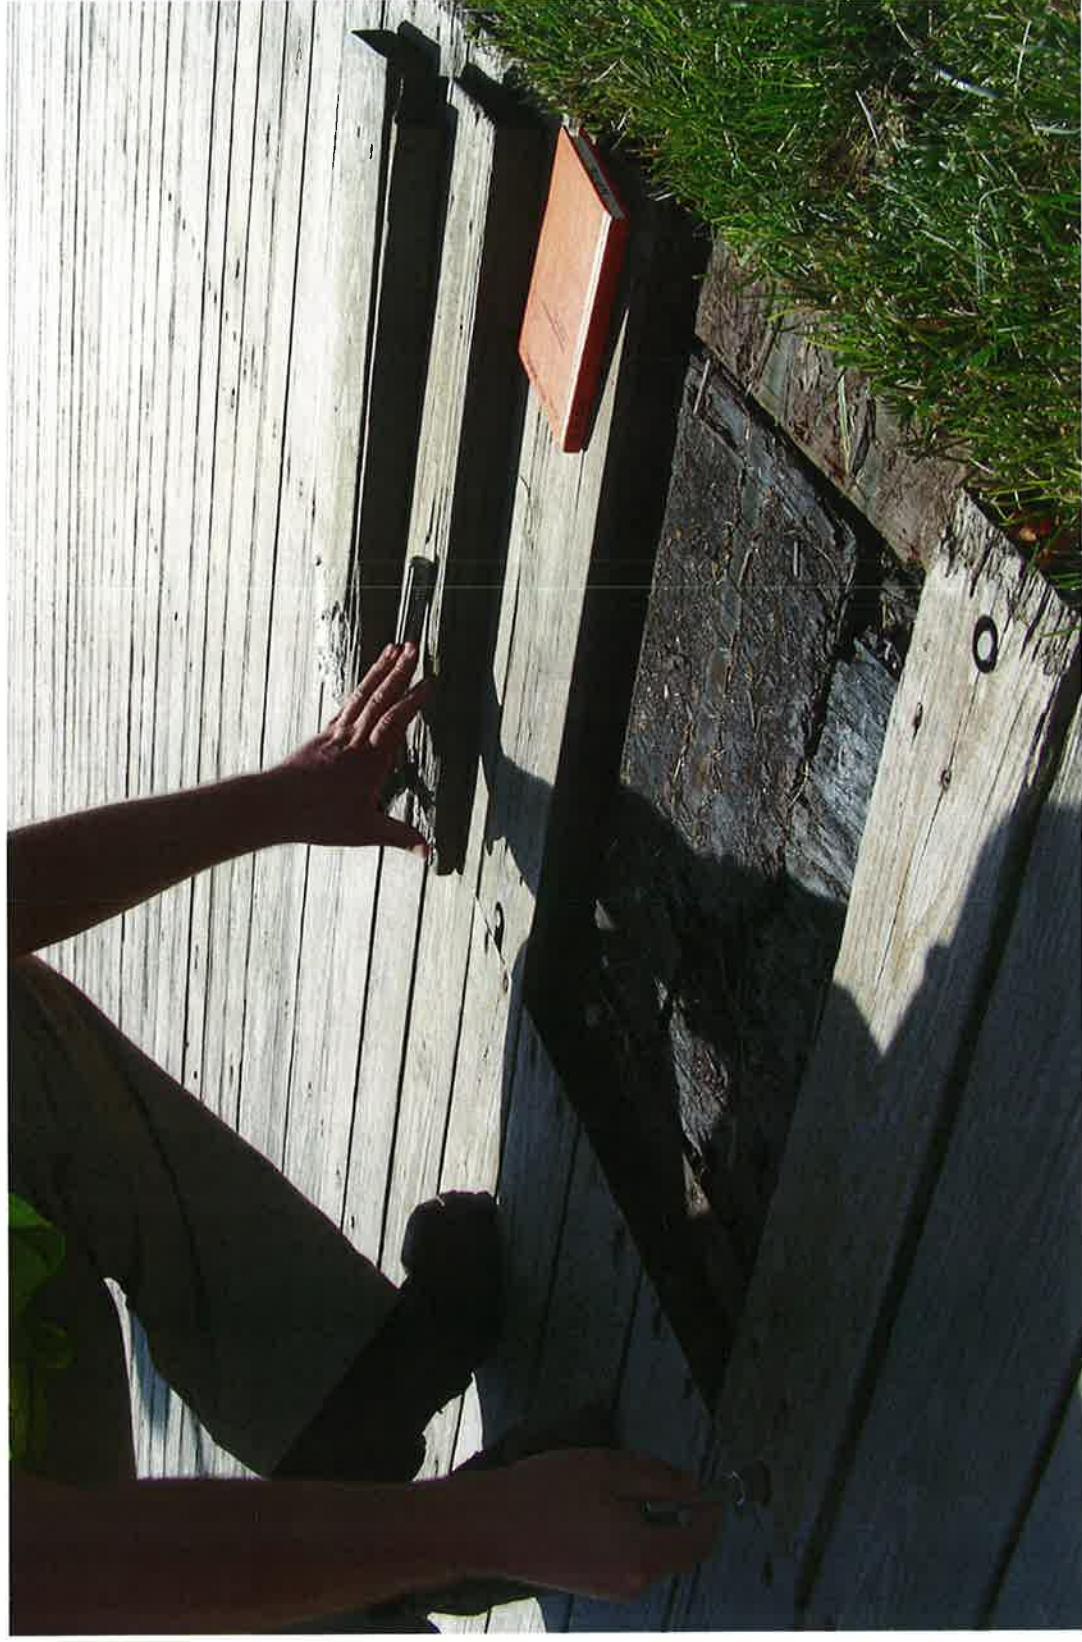
MW-7D: Extensive weathering has caused plywood covering well cap to deteriorate
